Quote

Charlotte Waste Water Plant
1005 Paine Drive
Charlotte, MI 48813

Ref: End suction pump for reconditioning

Dubric J.O.: 34559

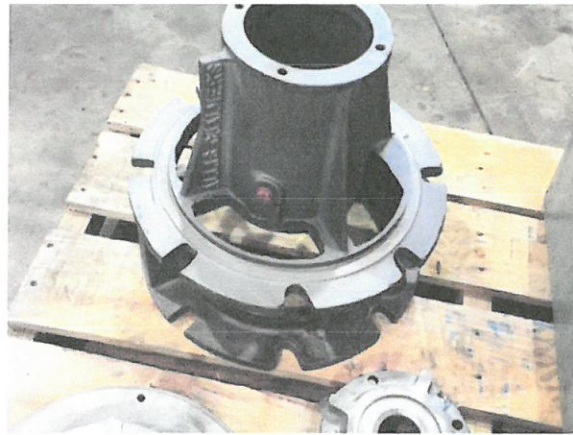
Radial bearing housing is within specification with no work required.

Bearing housing

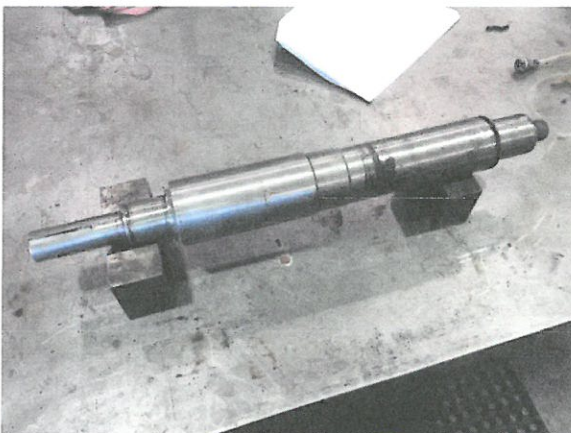
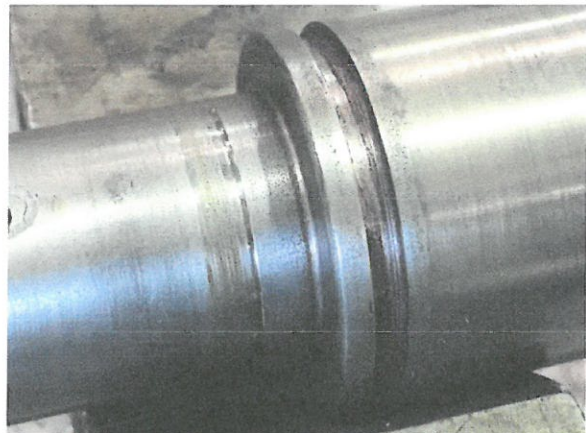
Main shaft is steel in construction and is in serviceable condition. Runouts were within acceptable limits. The radial bearing area, upper lip seal area and sleeve area show corrosion. We will repair these with chrome plating.

Shaft on left, lip seal fretting on right

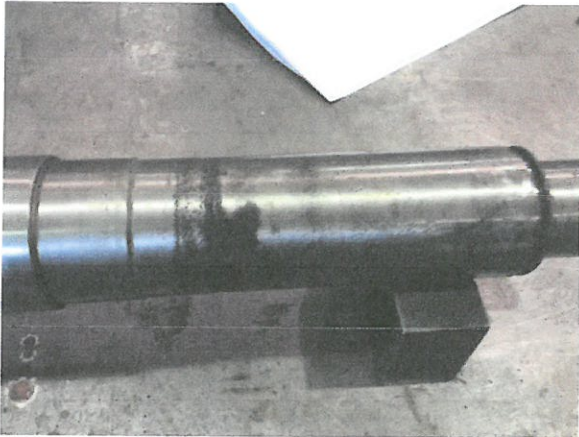
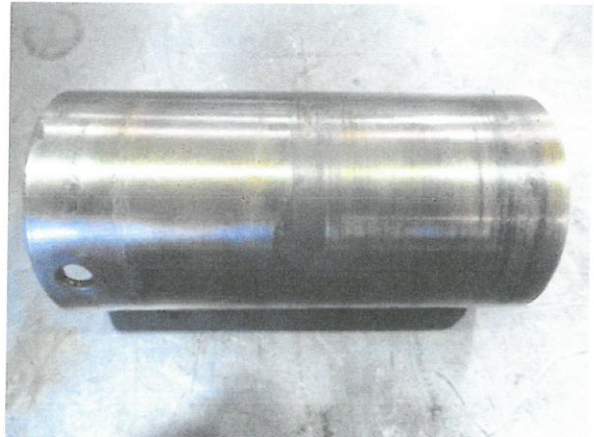
Shaft sleeve is 300 series stainless steel and has .008" runout. This will be fabricated as new from the same metallurgy. See option below for the pricing on this.

Corroded sleeve area on left and shaft sleeve on right

Fabricate a new seal sleeve from 300 series stainless steel. This includes all labor and materials for this repair.

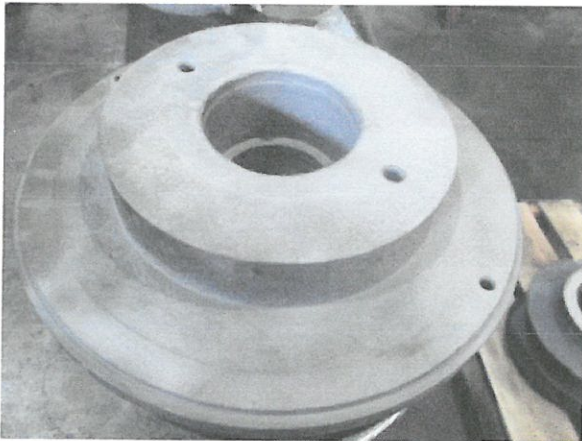
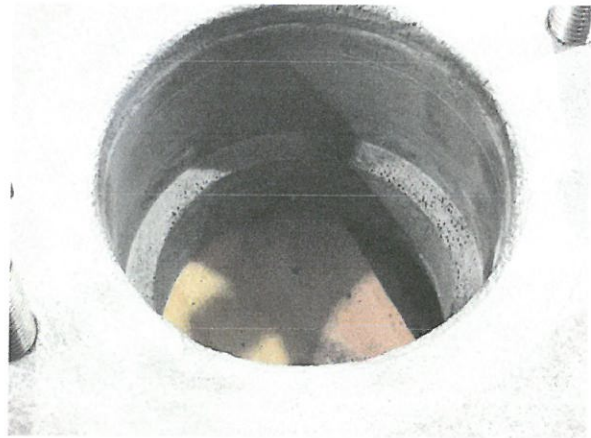
Backcover shows corrosion in the seal gasket area. We will face this to clean for a good gasket service for the Chesterton 442 seal. ARC coating will be recoated with two coats of ARC 855 material.

Stuffing box on left with corroded gasket area on right

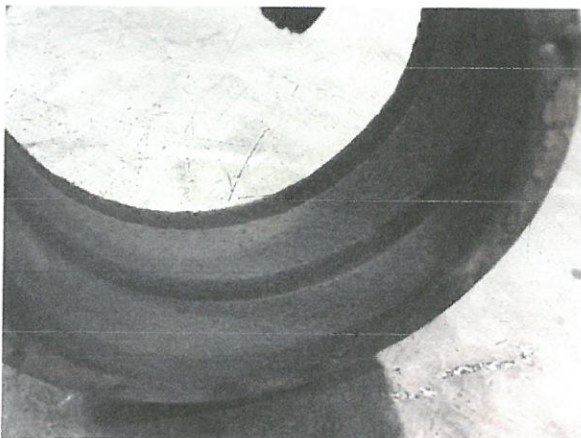
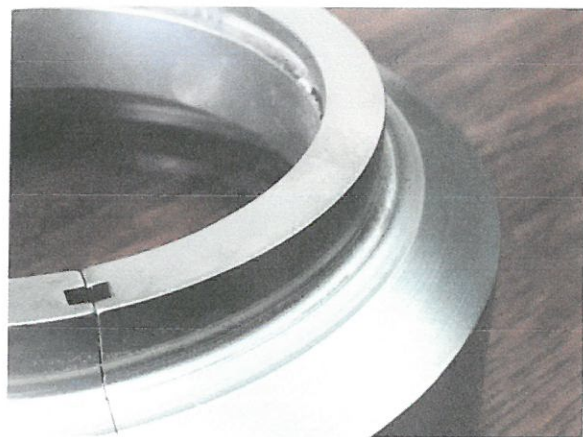
Sealing device is a Chesterton type 442 split seal size 2.750". The rotary holder shows wear and requires replacement with new from the OEM. The Spiraltrac bushing shows wear and will be replaced with new. The seal will be cleaned for reuse and need to be installed onsite once the impeller lift has been set.

Worn spiral track on left and worn rotary holder on right

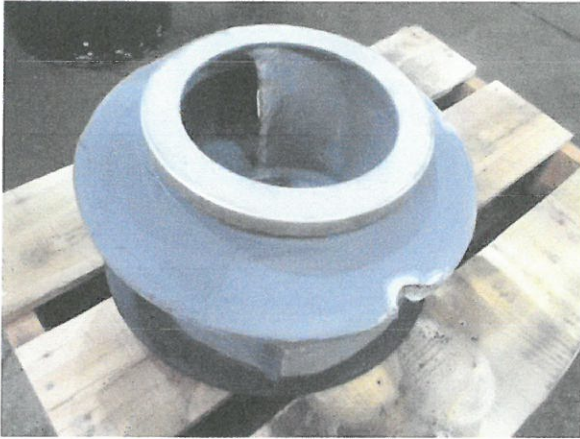
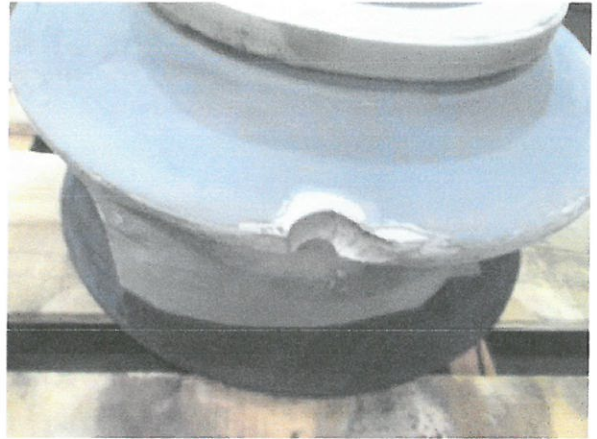
Impeller is cast iron in construction and has holes in various places around the impeller. The impeller has been coated previously with Chesterton metal repair coating. The coating is worn and missing on portions of the impeller. We will blast and apply two coats of ARC 855 metal repair system to repair the impeller. Low areas will be filled with ARC 858 metal repair system. Suction impeller ring is 400 stainless steel in construction and has minor wear. We will skim cut and reuse. We will balance of the impeller to ISO 1940 G2.5 specification for a smooth operating pump.

Impeller wear

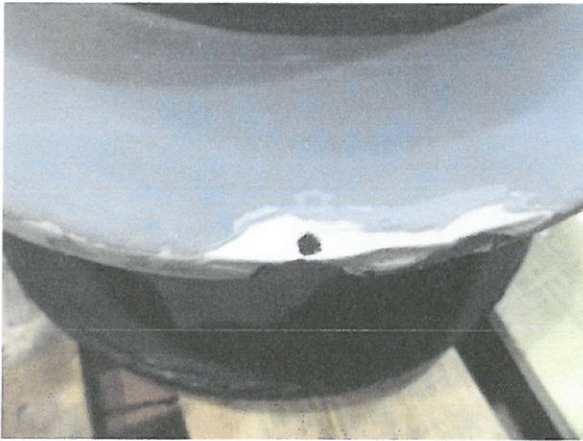
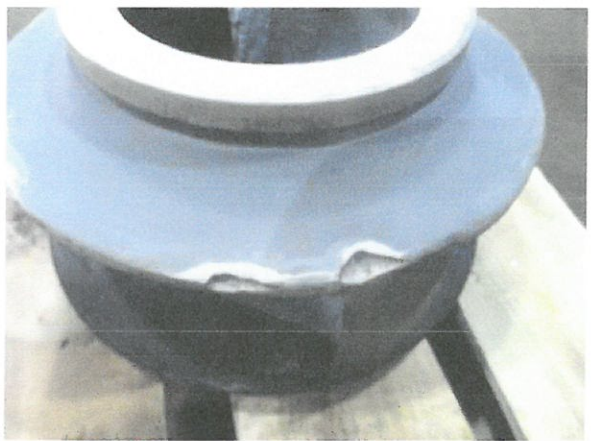
Impeller wear

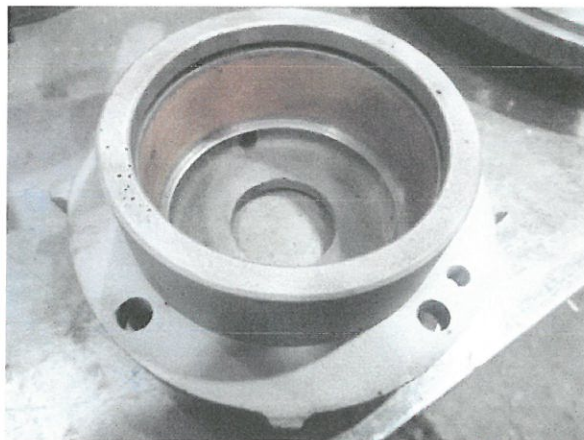
Thrust bearing cartridge is outside of tolerance by .002" and because this was metalized in the past chrome plating will not work as a repair method. We will replace this with new manufactured from steel. Please see option for this below.

Metallized thrust bearing housing

Fabricate a new thrust bearing housing from steel. This includes all labor and materials for this repair.

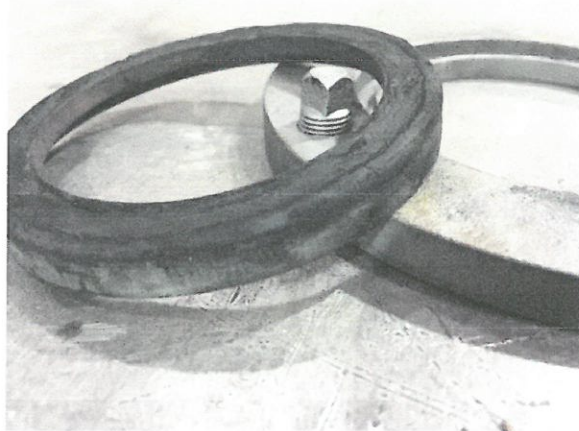
Bearing protection consists of flingers which have wear. We would suggest the customer purchase new for these parts from the OEM. These could be reused if the customer approved.

Worn flinger ring
